Uniform Mitigation Verification Inspection Form

Inspection Date: 07/18/2019		
Owner Information		
Owner Name: Magnolia Square Condo Inc.		Contact Person: R. Bryant
Address: 501 E. Bay Drive Bldg 1100		Home Phone:
City: Largo	Zip: 33770	Work Phone:
County: Pinellas		Cell Phone: (727) 243-0383
Insurance Company:		Policy #:
Year of Home: 1975	# of Stories: 2	Email: qscbuild@yahoo.com

Inspectors Initials RB Property Address 501 E. Bay Drive Bldg 1100 Largo

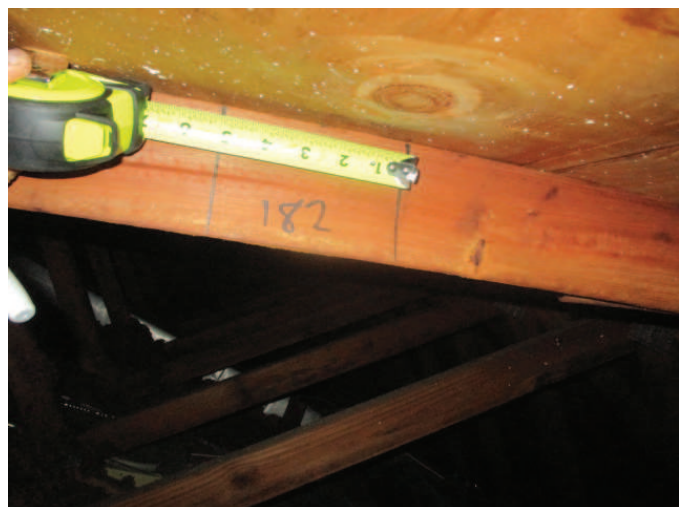
Roof Deck Attachment

- Roof Deck Attachment:** What is the weakest form of roof deck attachment?
 - A. Plywood/Oriented strand board (OSB) roof sheathing attached to the roof truss/rafter (spaced a maximum of 24" inches o.c.) by staples or 6d nails spaced at 6" along the edge and 12" in the field. -OR- Batten decking supporting wood shakes or wood shingles. -OR- Any system of screws, nails, adhesives, other deck fastening system or truss/rafter spacing that has an equivalent mean uplift less than that required for Options B or C below.

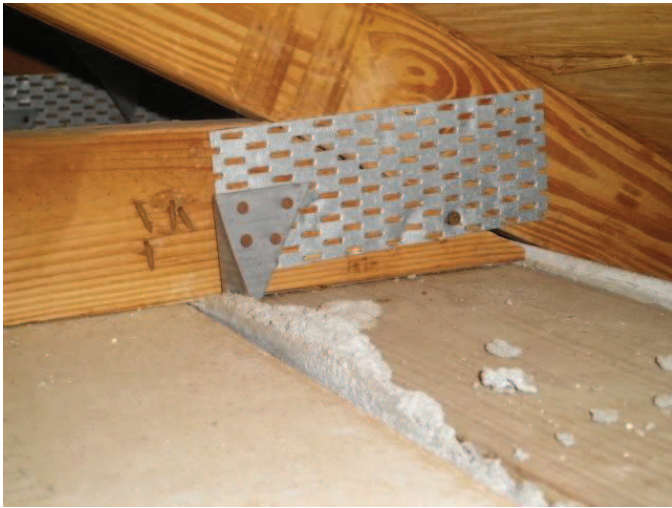
Roof to Wall Attachment

4. **Roof to Wall Attachment:** What is the **WEAKEST** roof to wall connection? (Do not include attachment of hip/valley jacks within 5 feet of the inside or outside corner of the roof in determination of WEAKEST type)
