# Uniform Mitigation Verification Inspection Form

Inspection Date: 07/18/2019		
<b>Owner Information</b>		
Owner Name: Magnolia Square Condo Inc.		Contact Person: R. Bryant
Address: 501 E. Bay Drive Bldg 200		Home Phone:
City: Largo	Zip: 33770	Work Phone:
County: Pinellas		Cell Phone: (727) 243-0383
Insurance Company:		Policy #:
Year of Home: 1975	# of Stories: 2	Email: qscbuild@yahoo.com

Inspectors Initials RB Property Address 501 E. Bay Drive Bldg 200 Largo

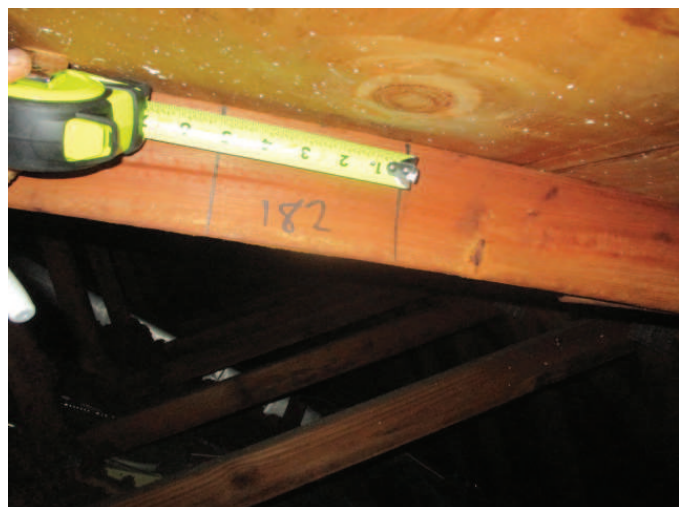
Roof Deck Attachment

- Roof Deck Attachment:** What is the weakest form of roof deck attachment?
  - A. Plywood/Oriented strand board (OSB) roof sheathing attached to the roof truss/rafter (spaced a maximum of 24" inches o.c.) by staples or 6d nails spaced at 6" along the edge and 12" in the field. -OR- Batten decking supporting wood shakes or wood shingles. -OR- Any system of screws, nails, adhesives, other deck fastening system or truss/rafter spacing that has an equivalent mean uplift less than that required for Options B or C below.
