Uniform Mitigation Verification Inspection Form

Inspection Date: 07/18/2019		
Owner Information		
Owner Name: Magnolia Square Condo Inc.		Contact Person: R. Bryant
Address: 501 E. Bay Drive Bldg 3100		Home Phone:
City: Largo	Zip: 33770	Work Phone:
County: Pinellas		Cell Phone: (727) 243-0383
Insurance Company:		Policy #:
Year of Home: 1975	# of Stories: 2	Email: qscbuild@yahoo.com

Inspectors Initials RB Property Address 501 E. Bay Drive Bldg 3100 Largo

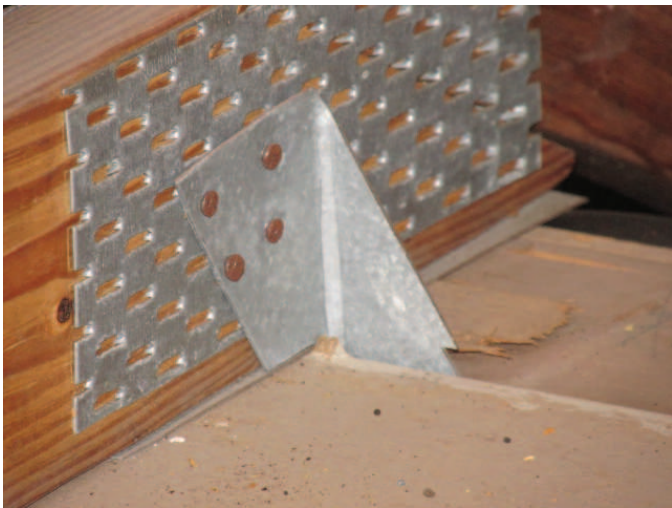
Roof to Wall Attachment

4. **Roof to Wall Attachment:** What is the **WEAKEST** roof to wall connection? (Do not include attachment of hip/valley jacks within 5 feet of the inside or outside corner of the roof in determination of WEAKEST type)

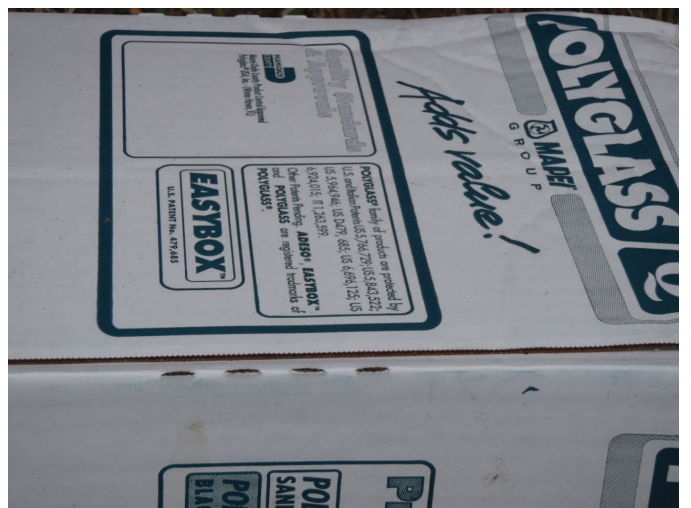
6. **Secondary Water Resistance (SWR):** (standard underlayments or hot-mopped felts do not qualify as an SWR)

- A. SWR (also called Sealed Roof Deck) Self-adhering polymer modified-bitumen roofing underlayment applied directly to the sheathing or foam adhesive SWR barrier (not foamed-on insulation) applied as a supplemental means to protect the dwelling from water intrusion in the event of roof covering loss.
- B. No SWR.
- C. Unknown or undetermined.
