# Uniform Mitigation Verification Inspection Form

Inspection Date: 08/18/2017		
<b>Owner Information</b>		
Owner Name: Magnolia Square Condo Inc.		Contact Person: R. Bryant
Address: 501 East Bay Drive #3600		Home Phone:
City: Largo	Zip: 33770	Work Phone:
County: Pinellas		Cell Phone: (727) 243-0383
Insurance Company:		Policy #:
Year of Home: 1975	# of Stories: 2	Email: qscbuild@yahoo.com

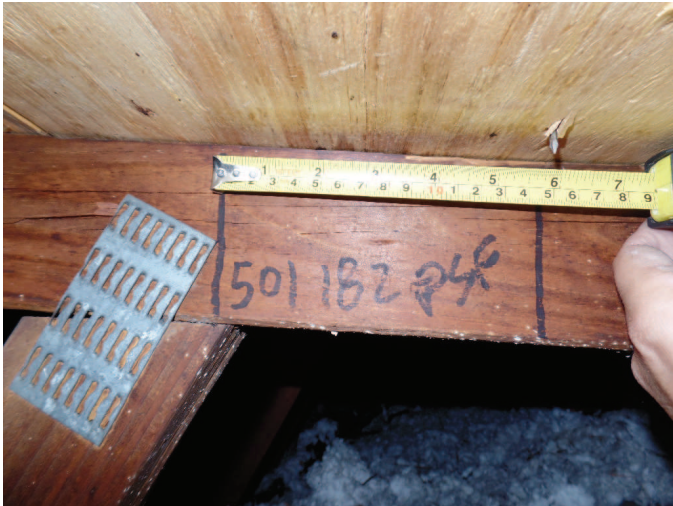
Roof Deck Attachment

- ☒ C. Plywood/OSB roof sheathing with a minimum thickness of 7/16" inch attached to the roof truss/rafter (spaced a maximum of 24" inches o.c.) by 8d common nails spaced a maximum of 6" inches in the field. -OR- Dimensional lumber/Tongue & Groove decking with a minimum of 2 nails per board (or 1 nail per board if each board is equal to or less than 6 inches in width). -OR- Any system of screws, nails, adhesives, other deck fastening system or truss/rafter spacing that is shown to have an equivalent

or greater resistance than 8d common nails spaced a maximum of 6 inches in the field or has a mean uplift resistance of at least 182 psf.

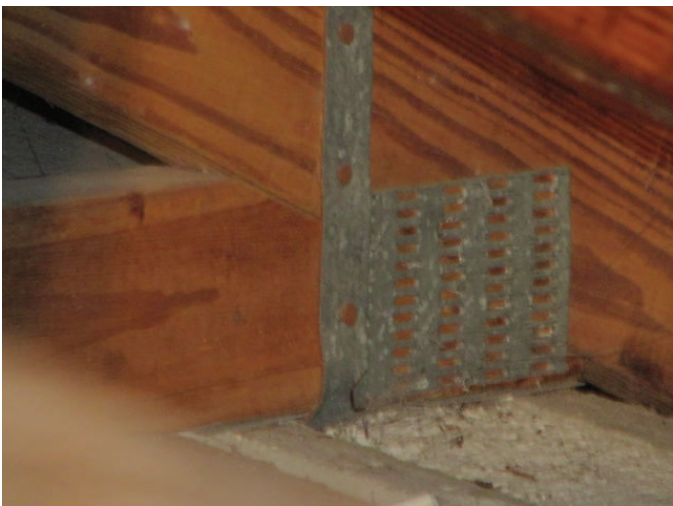
Roof to Wall Attachment

- ☒ Secured to truss/rafter with a minimum of three (3) nails, **and**
- ☒ Attached to the wall top plate of the wall framing, or embedded in the bond beam, with less than a ½" gap from the blocking or truss/rafter **and** blocked no more than 1.5" of the truss/rafter, **and** free of visible severe corrosion.

- ☒ B. Clips
  - ☒ Metal connectors that do not wrap over the top of the truss/rafter, **or**
  - ☐ Metal connectors with a minimum of 1 strap that wraps over the top of the truss/rafter and does not meet the nail position requirements of C or D, but is secured with a minimum of 3 nails.

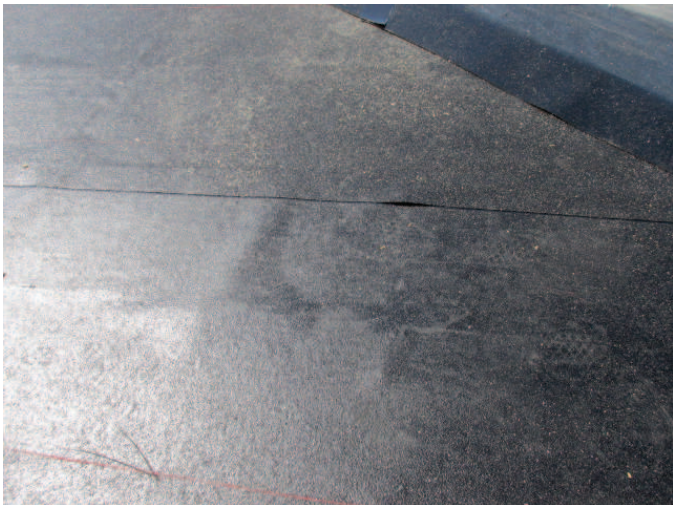
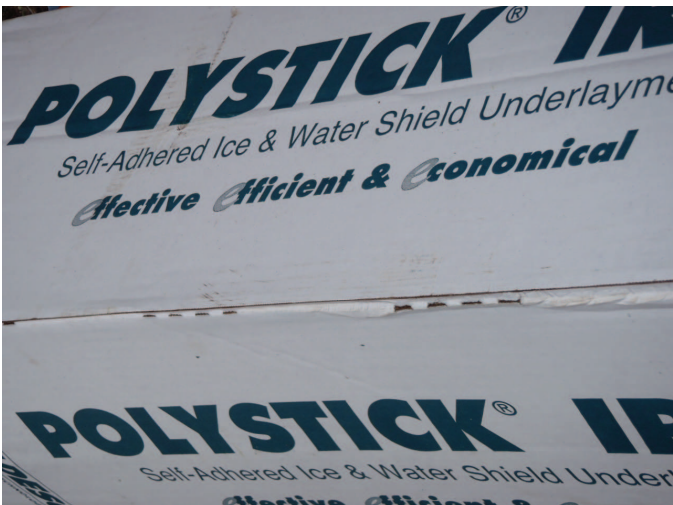
- ☒ A. SWR (also called Sealed Roof Deck) Self-adhering polymer modified-bitumen roofing underlayment applied directly to the sheathing or foam adhesive SWR barrier (not foamed-on insulation) applied as a supplemental means to protect the dwelling from water intrusion in the event of roof covering loss.
- ☐ B. No SWR.
- ☐ C. Unknown or undetermined.
