Uniform Mitigation Verification Inspection Form

Inspection Date: 03/15/2024		
Owner Information		
Owner Name: Magnolia Square Condominiums		Contact Person: R. Bryant
Address: 501 East Bay Dr. #400		Home Phone:
City: Largo	Zip: 33770	Work Phone:
County: Pinellas		Cell Phone: (727) 243-0383
Insurance Company:		Policy #:
Year of Home: 1975	# of Stories: 2	Email: qscbuild@yahoo.com

Inspectors Initials RB Property Address 501 East Bay Dr. #400 Largo

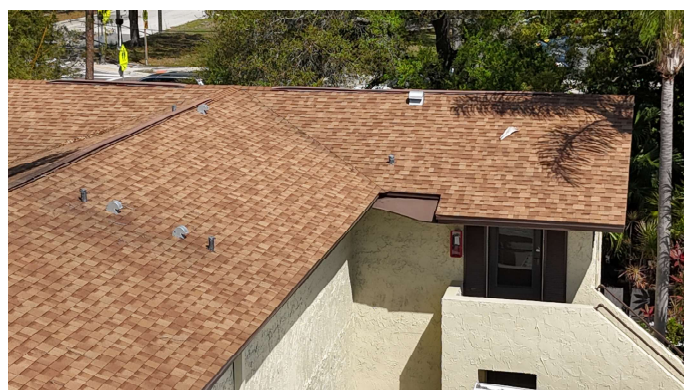
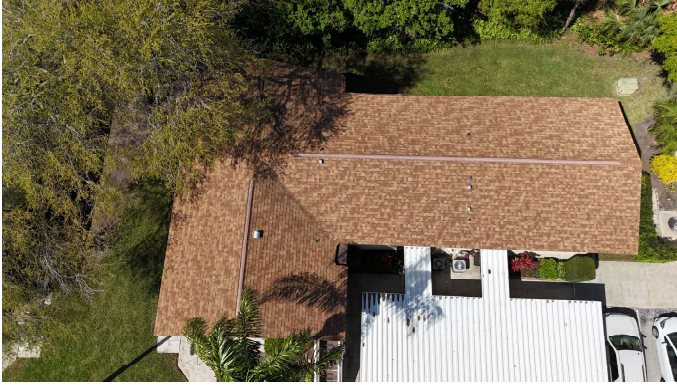
Roof Slope

5. **Roof Geometry:** What is the roof shape? (Do not consider roofs of porches or carports that are attached only to the fascia or wall of the host structure over unenclosed space in the determination of roof perimeter or roof area for roof geometry classification).
