Uniform Mitigation Verification Inspection Form

Inspection Date: 03/15/2024		
Owner Information		
Owner Name: Magnolia Square Condominiums		Contact Person: R. Bryant
Address: 501 East Bay Dr. #700		Home Phone:
City: Largo	Zip: 33770	Work Phone:
County: Pinellas		Cell Phone: (727) 243-0383
Insurance Company:		Policy #:
Year of Home: 1975	# of Stories: 2	Email: qscbuild@yahoo.com

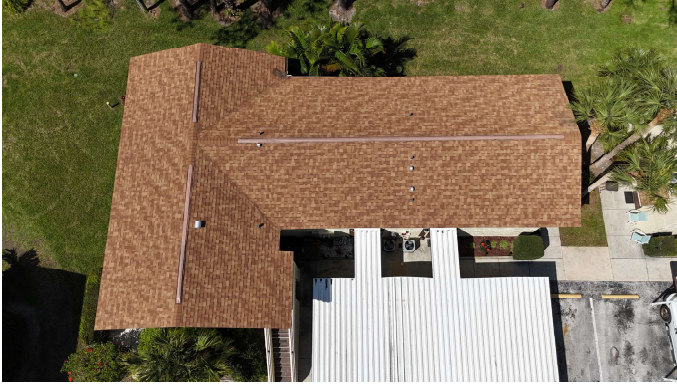
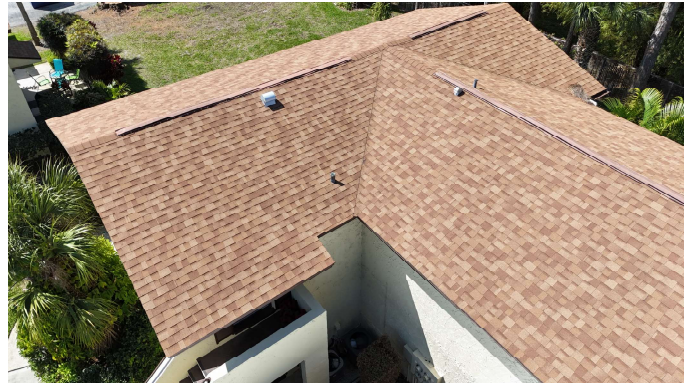
Roof Slope

5. **Roof Geometry:** What is the roof shape? (Do not consider roofs of porches or carports that are attached only to the fascia or wall of the host structure over unenclosed space in the determination of roof perimeter or roof area for roof geometry classification).

- A. Hip Roof Hip roof with no other roof shapes greater than 10% of the total roof system perimeter.
Total length of non-hip features: _____ feet; Total roof system perimeter: _____ feet
- B. Flat Roof Roof on a building with 5 or more units where at least 90% of the main roof area has a roof slope of less than 2:12. Roof area with slope less than 2:12 _____ sq ft; Total roof area _____ sq ft
- C. Other Roof Any roof that does not qualify as either (A) or (B) above.

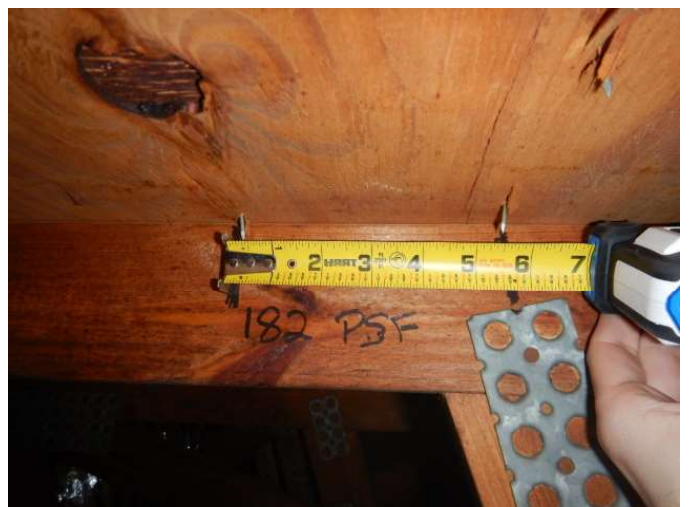
Roof Deck Attachment

3. **Roof Deck Attachment:** What is the weakest form of roof deck attachment?

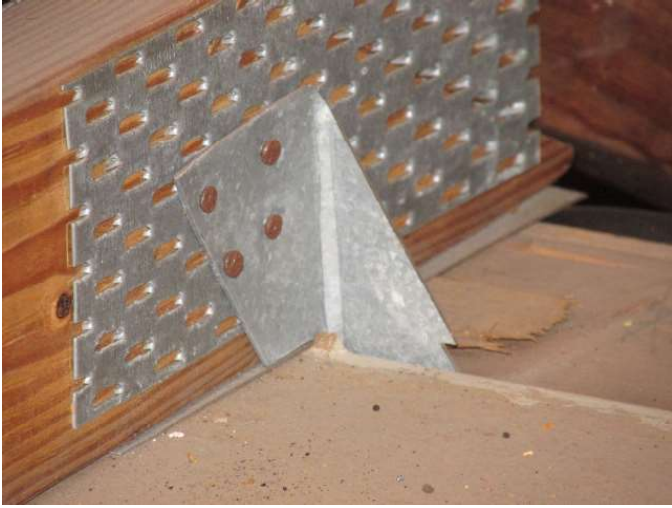
Roof to Wall Attachment

4. **Roof to Wall Attachment:** What is the **WEAKEST** roof to wall connection? (Do not include attachment of hip/valley jacks within 5 feet of the inside or outside corner of the roof in determination of WEAKEST type)

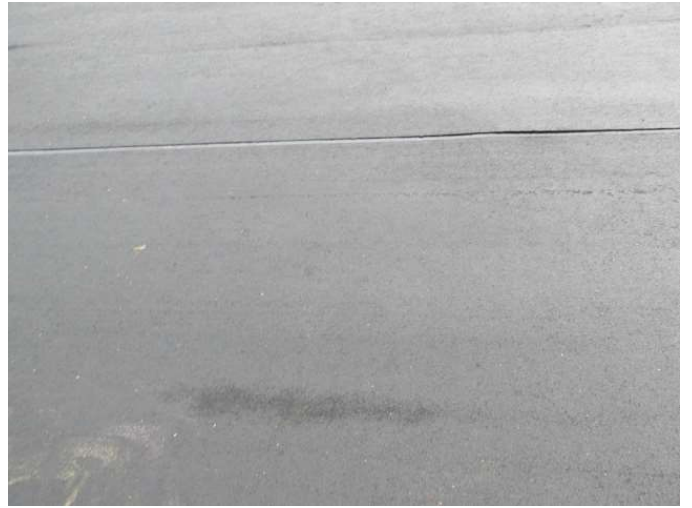
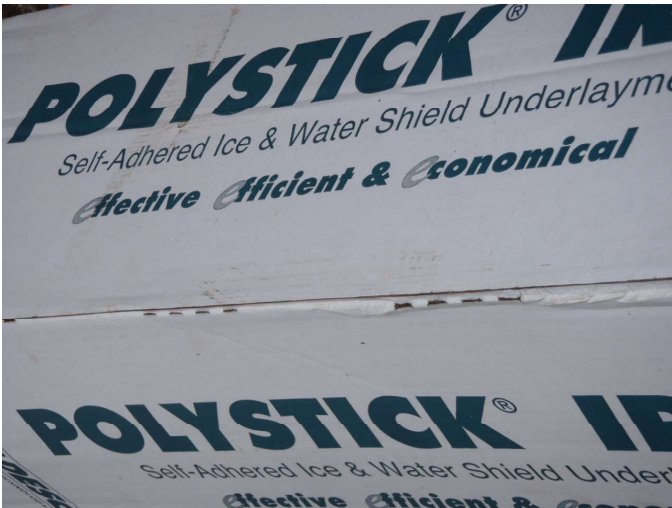
6. **Secondary Water Resistance (SWR):** (standard underlayments or hot-mopped felts do not qualify as an SWR)

- A. SWR (also called Sealed Roof Deck) Self-adhering polymer modified-bitumen roofing underlayment applied directly to the sheathing or foam adhesive SWR barrier (not foamed-on insulation) applied as a supplemental means to protect the dwelling from water intrusion in the event of roof covering loss.
- B. No SWR.
- C. Unknown or undetermined.
